An experimental investigation concerning the effect of AFP defects on progressive damage in CFRP coupons

ABSTRACT

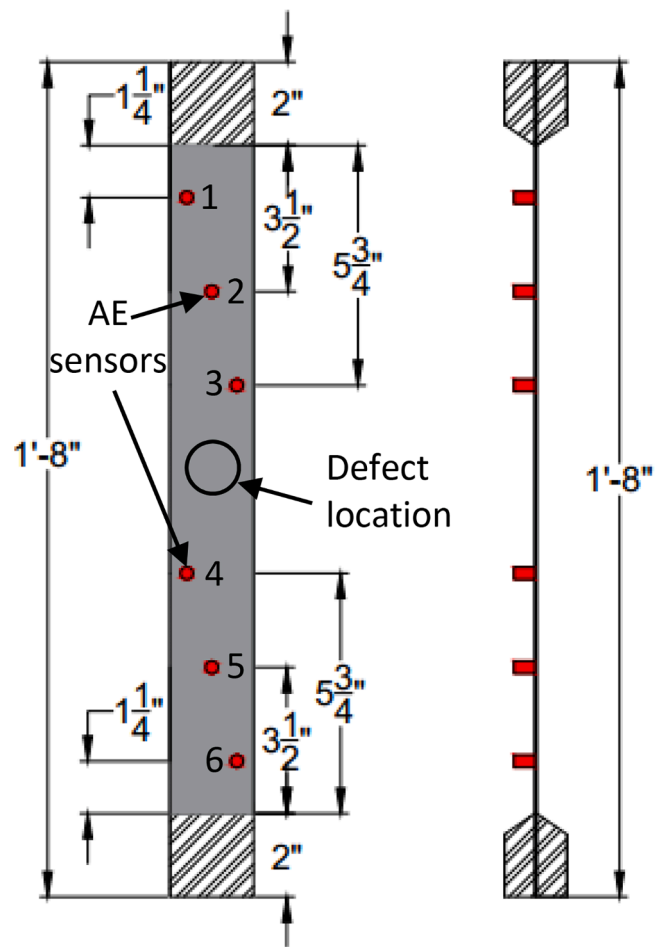
Fig. 1. Tensile Specimen Geometry and AE Sensor Layout.

The geometry of the tensile specimen is shown in Fig. 1. The thickness of each specimen, based on a ply thickness of $0.0055''$ (0.140 mm), was $0.0385''$ (0.9779 mm). The non-standard planar dimensions were implemented for two reasons: to provide more room for an inserted defect, located at the center of the specimen as denoted by the black circle (Fig. 1); and to generate improved results for the AE technique used during testing.

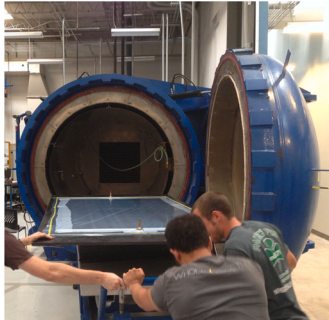
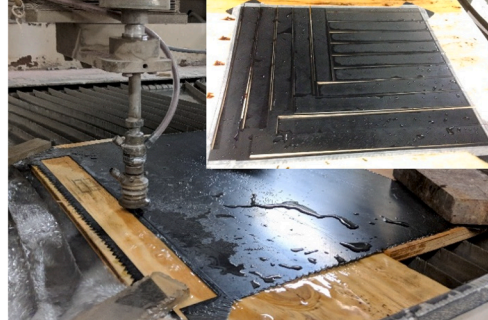
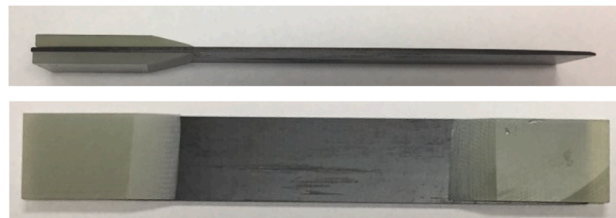
Fig. 3. Tensile Coupon Manufacturing Processes.

The AFP Lynx machine and autoclave at the McNAIR Center at the University of South Carolina (Fig. 3) were used to manufacture the panels using ¼ inch tows of Hexcel IM7-8552 material. Multiple tensile coupons were generated together as part of a single panel for each defect, with the coupon specimens being machined after cure using a water jet cutting apparatus (Fig. 3-c and 3-d). All plies were fiber placed with some defects being intentionally programmed into the part (gaps and overlaps) while the others were inserted by hand (twists and wrinkles). Pristine specimens for both the Ninety and Zero

configurations were fabricated as separate panels. After cutting, polishing and tabbing were completed (Fig. 3-e and 3-f). Three specimens representing each defect type were tested. Specimens were named as “Defect.Configuration.Specimen Number” as shown in Table 4 (i.e. P.0.1 refers to pristine, zero configuration, specimen number one).

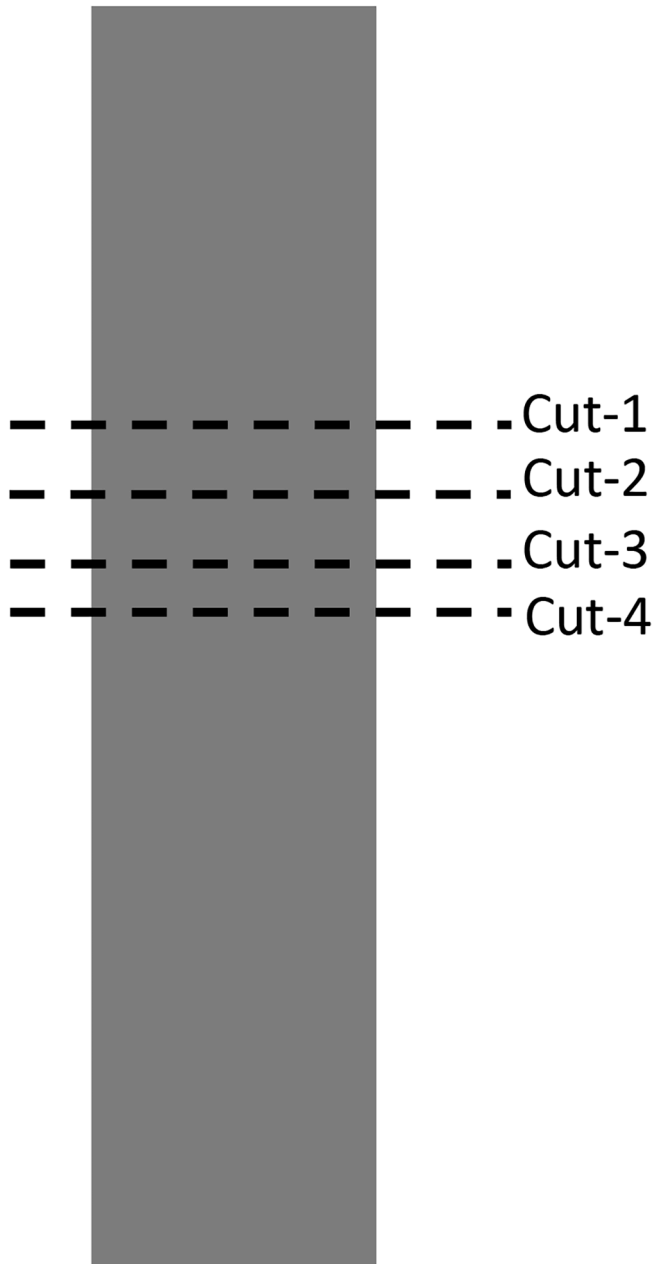
Fig. 6. Cutting planes for the twist defect.

For defects that cannot be inserted automatically, techniques were developed for by-hand insertion into the middle layer of the Zero configuration (the Ninety configuration did not provide enough length for useful insertion of such defects). Insertion of twists was completed by removing the center tow for a coupon and then re-inserting by hand, with one half-twist introduced into the middle tow of the Zero configuration. Care was taken to maintain consistency with respect to length for each twist. Because it is difficult through visual inspection at the edges in a similar way as gaps and overlaps to detect a twist embedded in the middle of the coupon and to fully capture these defects, multiple cutting planes (cut 1 through 4) are needed at different cross-sections (Fig. 6).

A four-inch-long twist was hand-placed in the panel and the resulting coupon was cut along the multiple planes as described in Fig. 6. For each cut, the specimen was polished to obtain a smooth surface. The resulting images captured using the digital microscope are shown in Fig. 7 for cutting plane 1 through 4 respectively. The progression of the twist formation is depicted starting with cut 1 where a small resin rich area is observed next to a fold both having a size of around 200 μm. The size of tow folded over itself as well as the size of the resin rich area increases

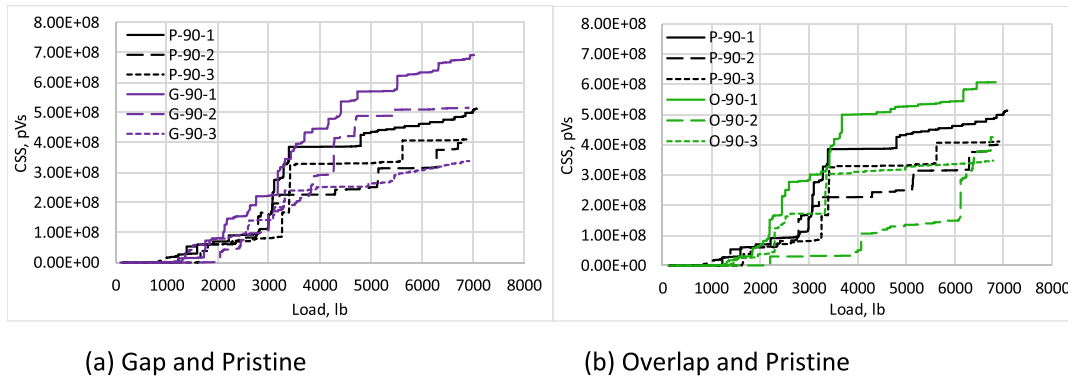
Fig. 15. CSS Versus Load of Ninety Configuration Specimens.

CSS compared with previous stages were observed and used to inform damage progression as load increased. Different ranges of crack behavior, illuminated by changes in the slope of the cumulative signal strength curve, can be detected for both Ninety and Zero configurations. Cumulative signal strength can be compared between specimens to estimate relative damage and identify the types of damage that each failure region represents. For instance, in a typical tensile test as shown in Fig. 13, the Ninety configuration showed lower damage than the Zero configuration under the same load (higher signal strength indicates more damage accumulation). This is due to the orientation angle composition of each stacking sequence. The Ninety configuration contains two axial (0°) plies as opposed to only one in the Zero

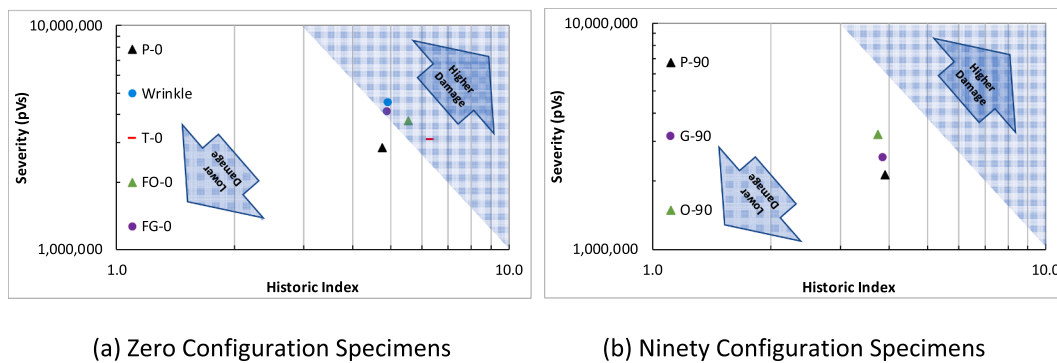
Fig. 16. Intensity Analysis Condition Assessment Charts of Tensile Specimens.

Intensity analysis was applied to evaluate the level of potential damage (i.e. matrix cracking, and delamination) occurring in the pristine and defect specimens under tensile loading. Fig. 16 shows the intensity analysis charts of tensile specimens. Each point in the figure represents the average value of three specimens. In Fig. 16a the high historic index and severity values approach the upper right corner of the charts indicating the most damage in defect specimens with Zero configuration compared to the pristine. In Ninety configuration, the difference between the defect and pristine specimens was not clear as the defect specimens have higher severity and lower historic indices compared to the pristine one. The reason is unclear, and it is noted that most of the pristine specimens have unintended defects. Moreover, the size of the defect may not have significant effect in Ninety configuration with higher stiffness compared to the Zero configuration with lower stiffness. Furthermore, the Zero configuration has higher historic index and severity values than Ninety configuration under the same load. This is attributed to AE activity with higher signal strength generated by crack initiation and growth in the Zero when compared to the Ninety configuration.

3. Intensity Analysis charts provided insight to the level of potential damage (i.e. matrix cracking and delamination) occurring in the pristine and defect induced specimens under tensile loading.

4. Defect induced tensile specimens showed higher historic and severity indices than pristine specimens, indicating the potential for acoustic emission evaluation to better understand the effect of AFP defects.

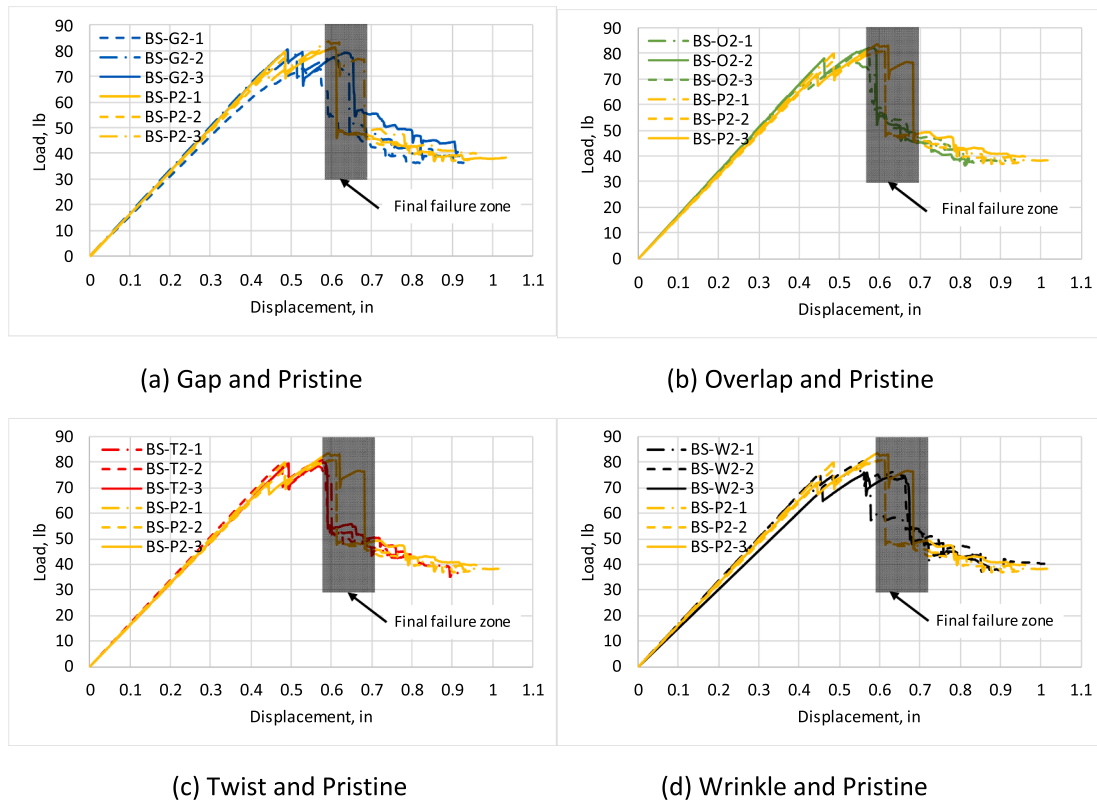
Fig. 17. Load-Displacement for of Three-Point Bending Specimens.

All specimens from each group had similar response curves (Fig. 17), with the initial matrix cracking leading to delamination. After the initial load drop, delamination also occurred on the side of the doubler which led to final separation and overall failure (Highlighted failure zone in Fig. 17).

The gap configuration curves (Fig. 17a) predominately mirror the

pristine results with the initial matrix cracking side leading to initial delamination there, though the second peak after delamination tends to be not as pronounced for the gap specimens. In general, not much effect of the gap defect is observed.

While the responses of twist configuration (Fig. 17c) do not deviate far from the pristine baseline, it was observed that the second ultimate failure peak often does not exceed the initial peak value. More tests and additional techniques should be employed to detect and explain this effect. Lastly, with wrinkle defects (Fig. 17d) one would suppose that it would most closely resemble the overlap configuration (added material near the failure point), though the effect does not seem as prominent.

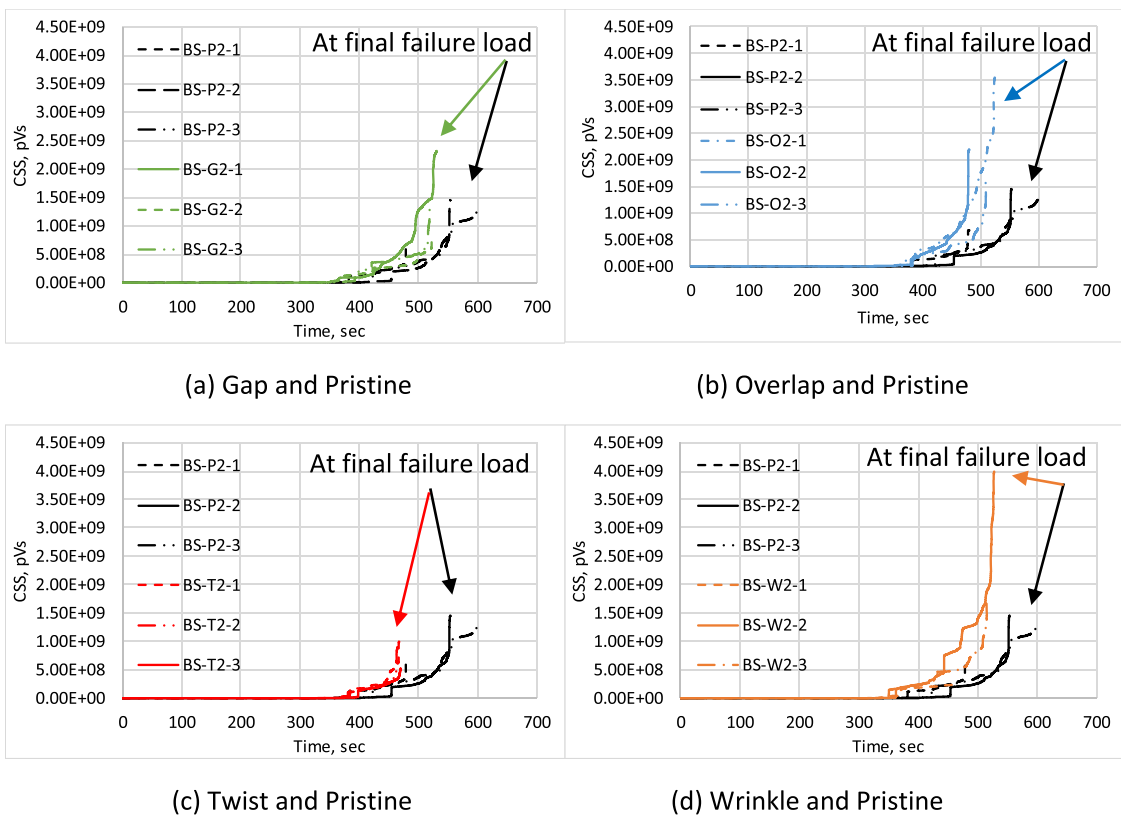
Fig. 20. CSS Versus Time of Three-Point Bending Specimens.

Cumulative signal strength (CSS) curves of pristine and defect specimens are shown in Fig. 20. As explained in the tensile specimen section, this parameter aids in evaluation of the level/type of damage that is occurring within the specimen and in defining failure regions. Several significant jumps in CSS compared with the previous stages were observed and used to inform damage progression as load increased. Different ranges of crack behavior, illuminated by changes in the slope of the cumulative signal strength curve, can be detected for both pristine and defect configurations. To estimate relative damage and also identify the types of damage, CSS curves of both configurations are compared as shown in Fig. 20. For instance, earlier damage indicated by higher CSS was introduced by each defect group compared with the pristine group. In other words, the Pristine configuration showed lower damage than the defect configuration under the same load (higher signal strength indicates more damage accumulation). All curves in Fig. 20 were plotted up to ultimate failure load as shown in the highlighted regions in Fig. 17.

5. Cumulative Signal Strength (CSS) clearly shows the effect of double defects induced in three-point bending specimens. Higher damage was observed earlier in defect induced specimens than in pristine specimens.

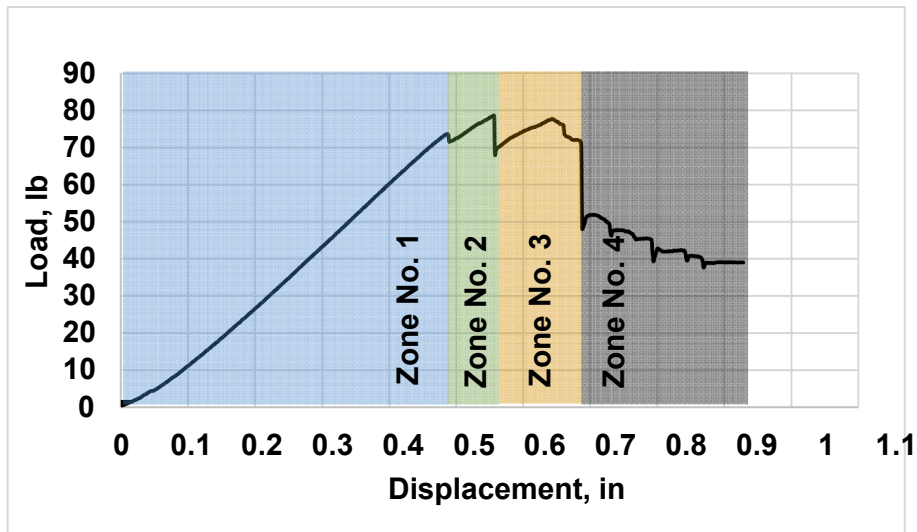
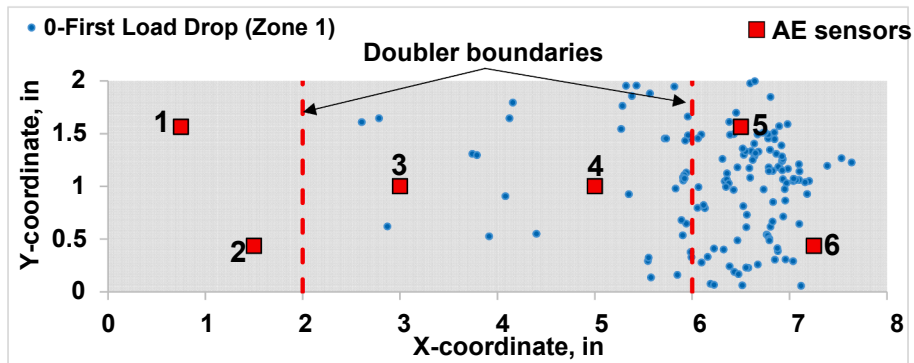
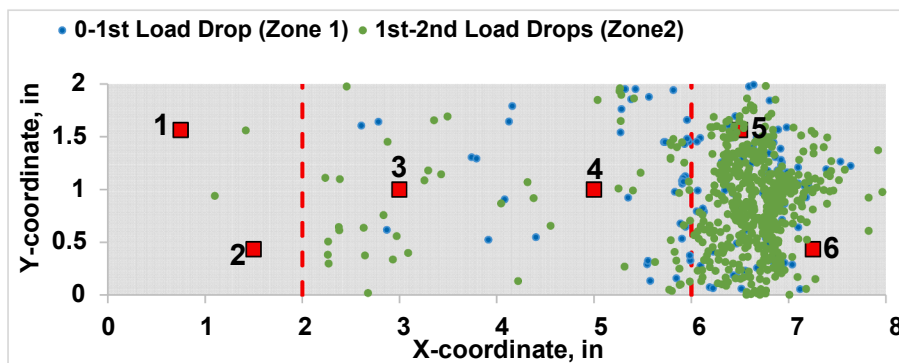
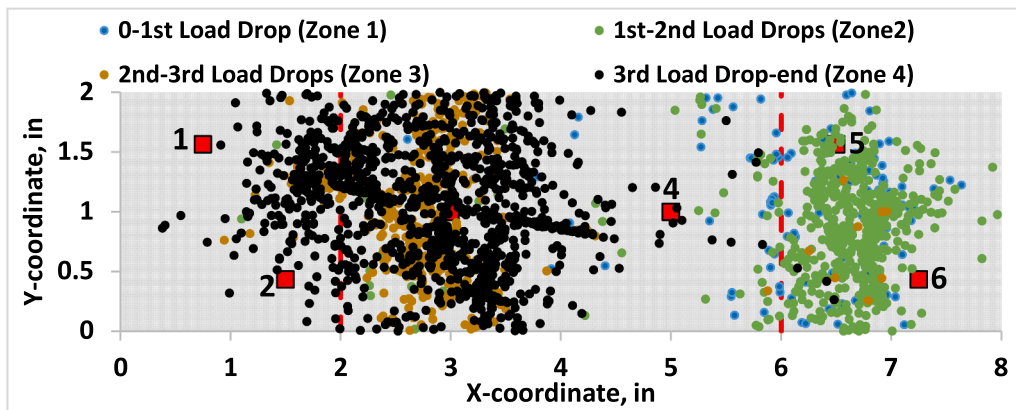
Fig. 21. AE source location for BS-G2-2 specimen during bending test.

divided into four zones based on the load drops record. Then, source localization algorithm was applied to represent the AE events in 2D plots based on the time frame of each zone as illustrated in Fig. 21b–e. From the beginning of the test to the first load drop (zone 1), most of AE events were located at the right side of the specimen (Fig. 21b) where the first crack happened (step 3 in Fig. 19). During zone 2, as crack extension occurred from the right side towards the mid of the specimen (steps 4 and 5 in Fig. 19), more AE events were detected as described in Fig. 21c. For the period of zones 3 and 4, the second crack was initiated and progressed at the left side of the specimen (steps 6–8 in Fig. 19). This caused substantial amount of AE events collected at the left side as shown in Fig. 21d, e. It can be concluded that AE source localization results agreed with the vertical strain contour described by DIC technique and load–displacement response. Also, it can be used to describe failure developments of bending specimens.

6. An acoustic emission 2D source localization algorithm describes damage progression of bending specimens and agrees with DIC images and load–displacement response.
